# Bio-Engineered Stream Bank Stabilization on the Teton River

by Katie M. Salsbury, Principal, Intermountain Aquatics and Native Sod Solutions

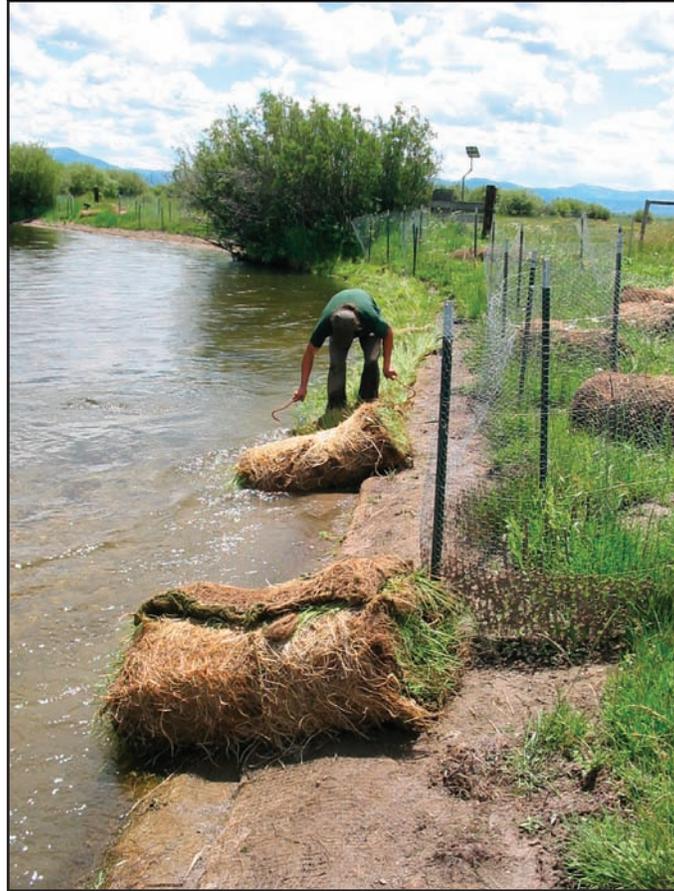
**Wetland Sod installation.**

Wetland Sod was developed and tested to rapidly establish key wetland species on wetland restoration and mitigation sites. It is a pre-planted erosion control mat grown with native plants to produce maximum root growth.

Because installation of the Wetland Sod during the fall would not allow the plants to root before the peak, run-off event; it was installed using 12-inch lath staking every 8 square feet after the spring run-off in July of

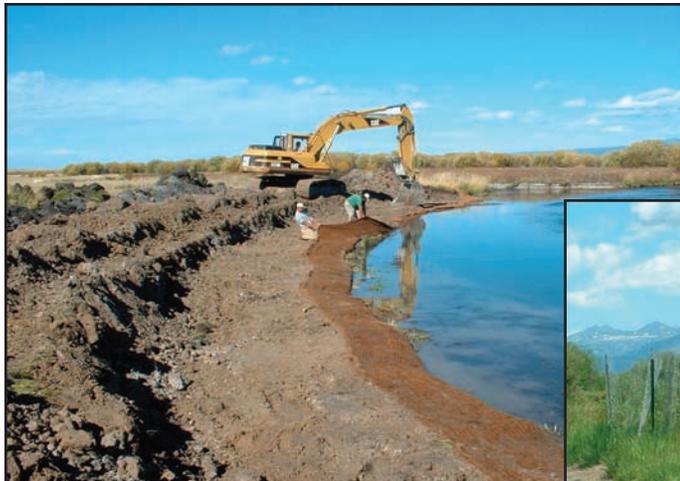
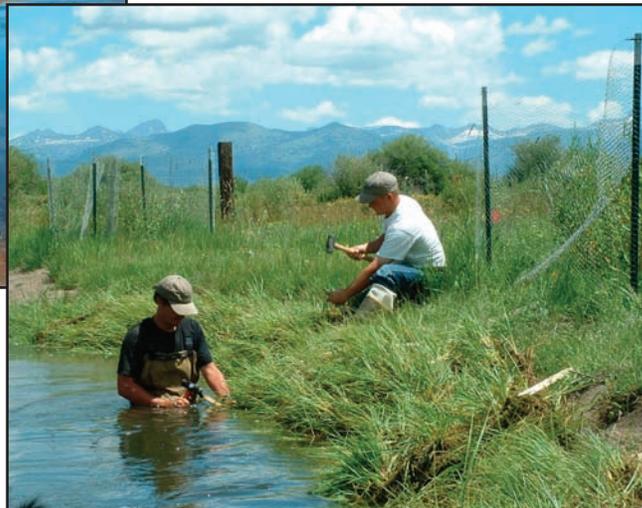
**Top: Construction of the first soil terrace. Lower: Site conditions during Wetland Sod installation.**

Each eroding bank was reconstructed by first excavating the bank down to the base-flow water line to a width of 15 feet.

Two layers of erosion control fabric were staked onto the base of the excavated bank using 8-inch wire staples. Soil was compacted onto the erosion control fabric layers to a depth of 10 inches. Approximately 3 feet of the erosion control fabric was wrapped up onto the compacted soil to build the initial toe and first terrace of

the reconstructed bank. On most sites, this technique was repeated to construct a second terrace, off-set by 3 feet from the lower one. The remaining soil was sloped back to create a bank with an average slope of 4:1. Disturbed areas were seeded with a xeric mix and 5 gallon, containerized willows and dormant willow cuttings were installed above the second soil terrace. This work was completed in the late fall of each year to insure that the terraces were constructed during base-flow conditions.

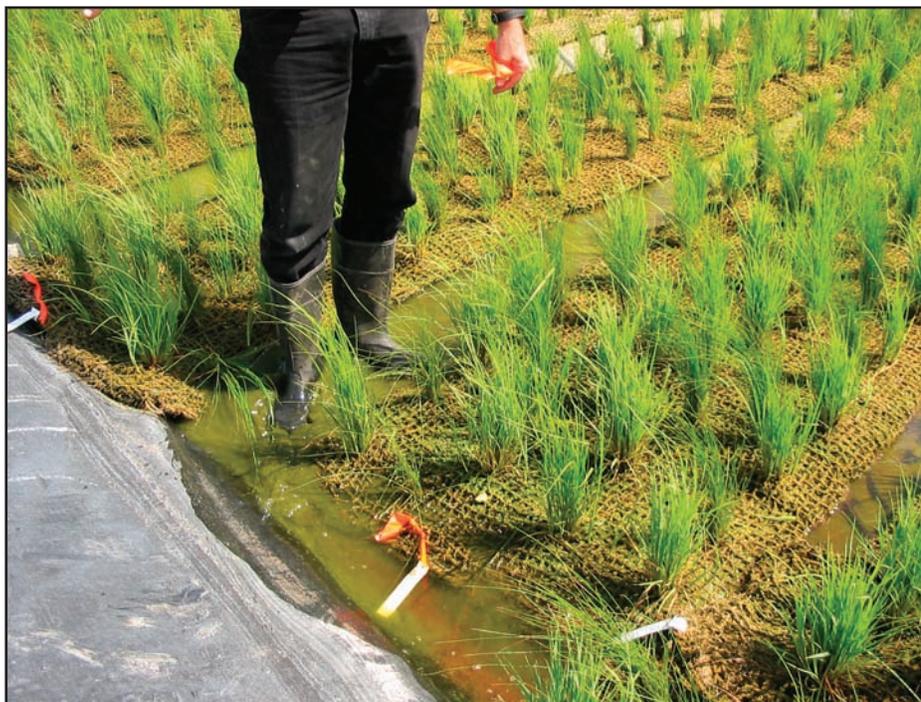
**The pre-planted erosion control mat is grown with native plants to produce maximum root growth.**
