Bio-engineered Stream Bank Stabilization using WETLAND SOD

WETLAND SOD in combination with erosion control fabric was used to reconstruct and stabilize eroding stream banks on the Teton River in southeast Idaho (elevation 6,000 ft). This method was developed to establish slopes and plant communities similar to those found on stable, natural reference banks found throughout the upper Teton River system and to provide an alternative to traditional rip-rap.

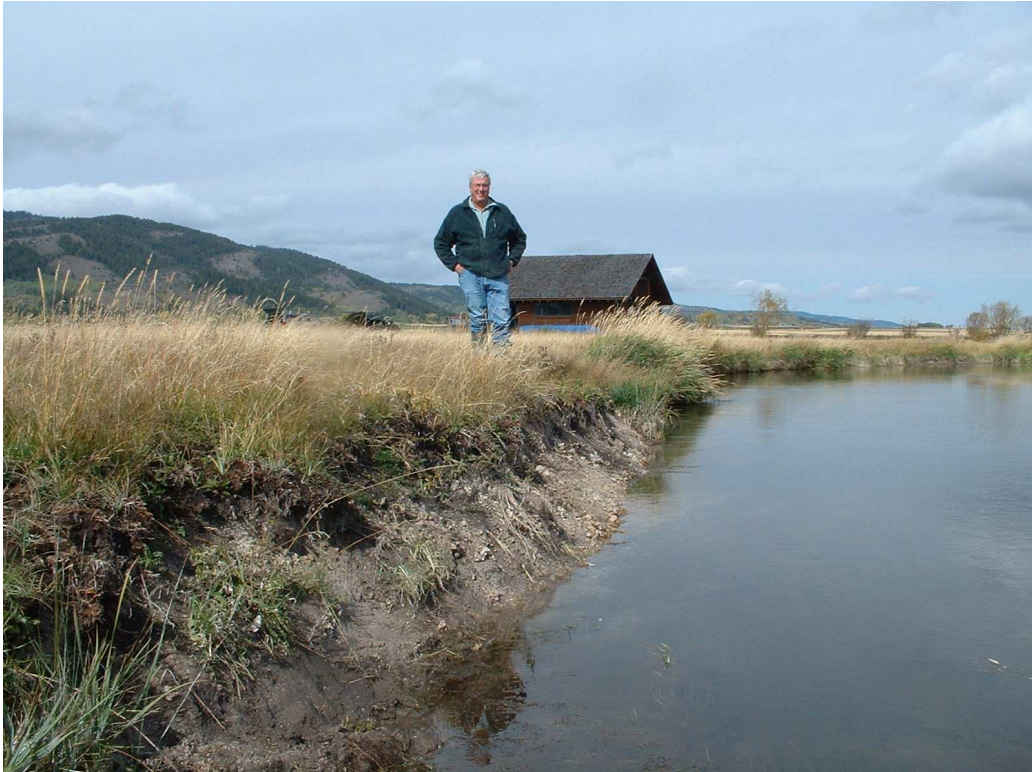
The Teton River has an average base flow of 250 cfs. and an average peak flow of 1,500 cfs. Above and throughout the study area the Teton River is a predominantly ground water fed, free flowing system with a moderate spring run-off. Conditions at the study sites pre-construction included an average bank height of 3.5 – 5 ft, an average bank slope of 1:1 (or steeper) and dominant bank vegetation consisting of introduced pasture grasses. The dominant soil type was a silty clay loam.

Before Conditions (October 2002).

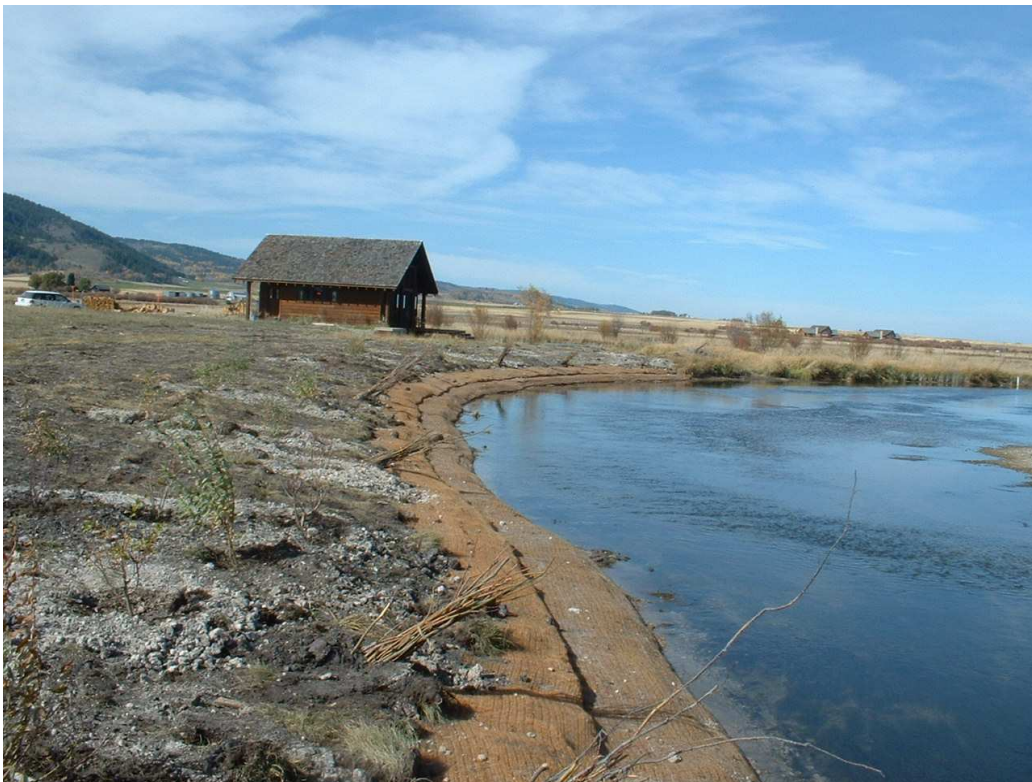
Willows and Soil Lifts Installed (October 2002).

Each bank was reconstructed by first excavating the bank down to the base-flow water line to a width of 6.5 ft. Two layers of long-term erosion control fabric were staked onto the base of the excavated banks using 8 in. wire staples. Soil was compacted onto the erosion control fabric layers to a depth of 8 in. Approximately 3 ft of the erosion control fabric was wrapped up onto the compacted soil to build the initial soil lift of the reconstructed banks. A second soil lift was constructed approximately 3 ft behind the first lift using the same methods. The remaining soil was sloped back to create a bank with an average slope of 4:1. WETLAND SOD, a pre-vegetated coir mat containing mature native plants, was installed in two rows onto the constructed soil lifts to a width of 6 ft. Containerized willows were planted at a density of 1 willow per 5 ft and both rooted and dormant cuttings were installed though out the project area. All disturbed areas were seeded with a mesic species mix. The project was irrigated throughout the first growing season and the upland areas were spot sprayed for weed control.

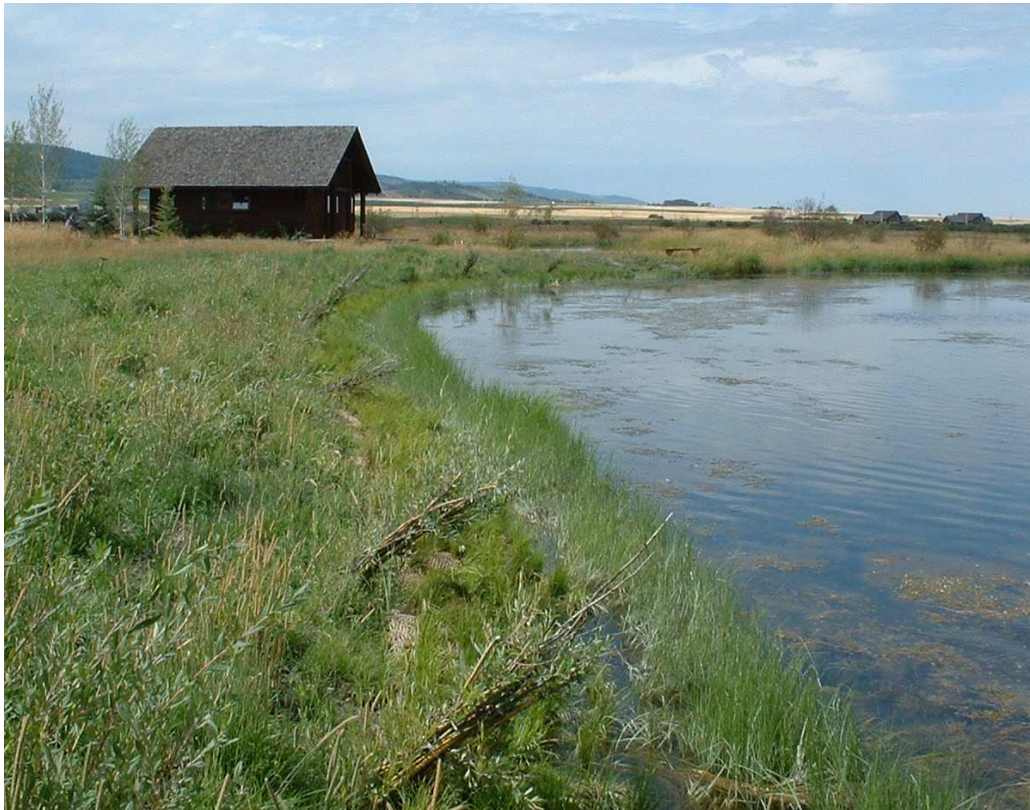
Wetland Sod Installed (August 2003).

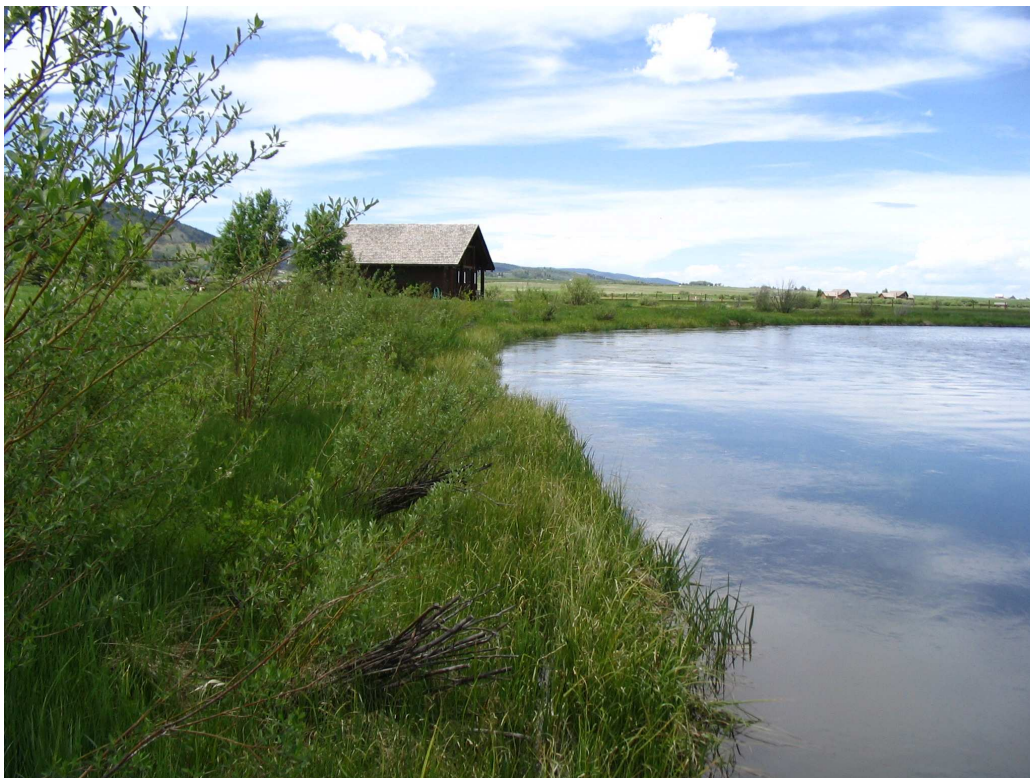
A total of 4,400 linear ft of eroding bank was reconstructed from 2002 through 2003 at 6 individual sites for a cost of \$75 per linear ft. This price included design, permitting, construction, revegetation, irrigation and weed control. Bank treatments successfully established native plant communities and withstood cattle trampling, grazing and peak flow events within 1 year post-construction.

Post - project Conditions (August 2008).
